REFURBISHMENT STRUCTURAL STRENGTHENING WITH SIKA SYSTEMS

FOR OWNERS OF BUILDINGS AND CIVIL ENGINEERING STRUCTURES

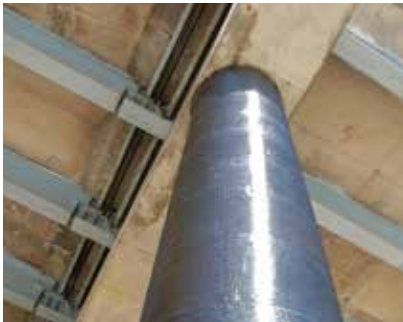
COLUMN STRENGTHENING

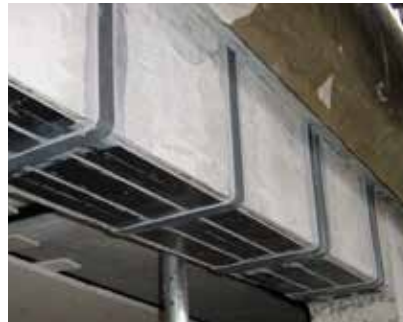
BEAM STRENGTHENING

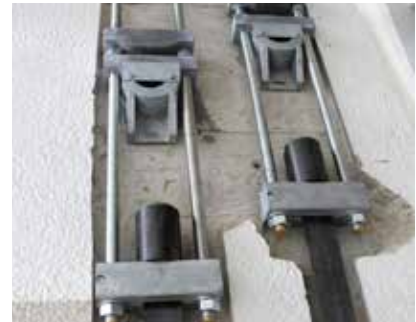
PRE-STRESSED STRENGTHENING

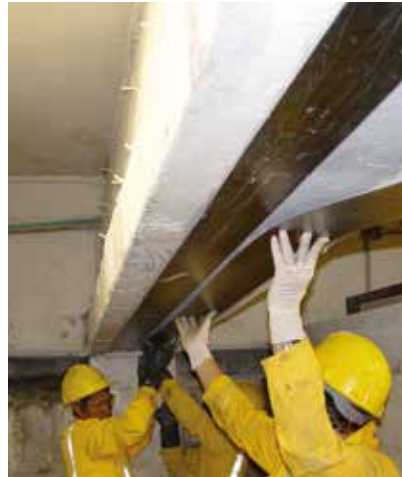
The Sika CarboDur® System is the most widely recognized and established carbon-fiber-reinforced polymer (CFRP) strengthening solution available worldwide. It consists of Sika CarboDur® CFRP plates and rods, together with the structural epoxy resin based adhesives Sikadur®-30 and Sikadur®-30 LP. This simple, tested and well proven, highly durable system has outstanding performance. With the Sika CarboHeater curing times can be accelerated and down time minimized, even at lower temperatures.

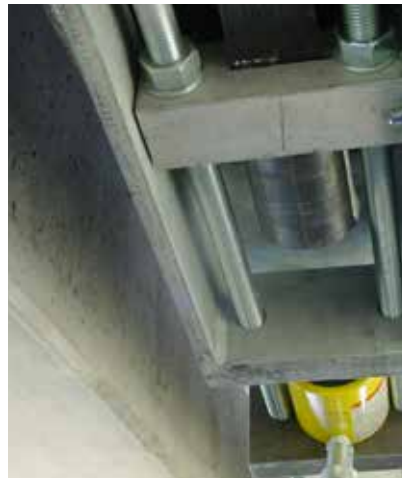
Post-tensioning: a force is applied to create permanent stress in a structure, so that it can withstand load more efficiently or with less total deflection. In conventional post-tensioning, the load is put on steel tendons within the concrete structure, however with the Sika CarboStress® system, the advantages of the Sika CarboDur® CFRP plates and post-tensioning techniques are combined to form a unique active external strengthening solution.

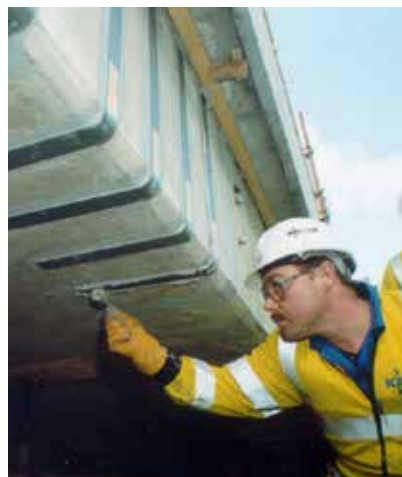
The shear capacity of concrete beams can be increased by the external applied Sika CarboShear L-shaped profiles. Installation is fast and easy, excellent anchorage is assured and no drilling through the top slab is required.

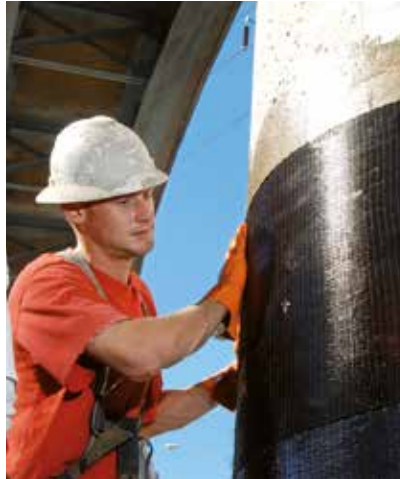
The SikaWrap® fabric strengthening system consists of woven or stitched, unidirectional, carbon and glass fibre fabrics and Sikadur® impregnating resins. This system provides a wide range of solutions to meet different demands on many different types of projects. The installation is extremely flexible and accommodating of different surface planes and geometry, making this a very multi-functional material for many applications including confinement, shear, seismic upgrading and weak substrate strengthening.

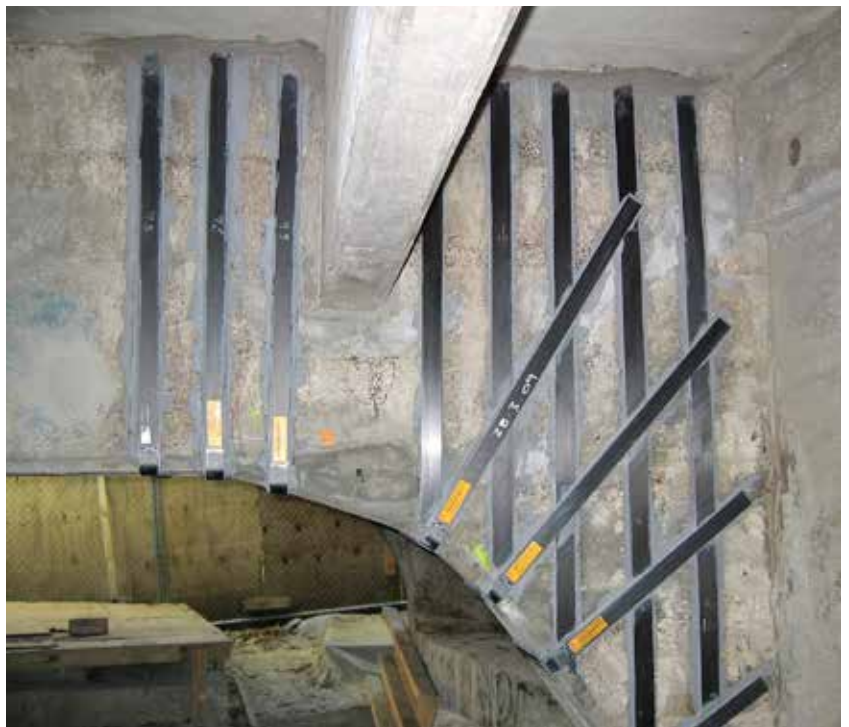
Sika CarboDur® strips and CarboShear L plates bonded to the concrete structure.

Sika CarboDur® CFRP plates were installed on the underside of the reinforced concrete beams to provide additional mid-span movement resistance. The Sika CarboShear L shaped CFRP profiles were then installed, in pairs, around the beams and up into the deck slab to improve the shear performance.

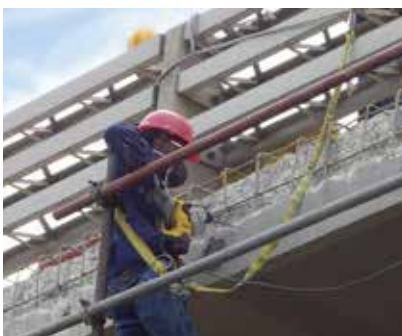
Substrate preparation

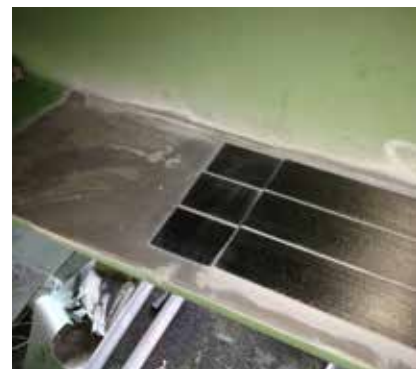
Two layers of Sika CarboDur®

CarboDur® system. After the steel substrate was cleaned and prepared by abrasive blast cleaning, the prefabricated CarboDur® CFRP plates were then immediately bonded to the steel surface with Sikadur® structural adhesive. With these strengthening measures, the mechanical characteristics of the structure were increased and the amplitudes of stresses due to movement were reduced; thus the service life of the bridge was significantly extended. This was the first experience in France of strengthening this type of structure with bonded CFRP.

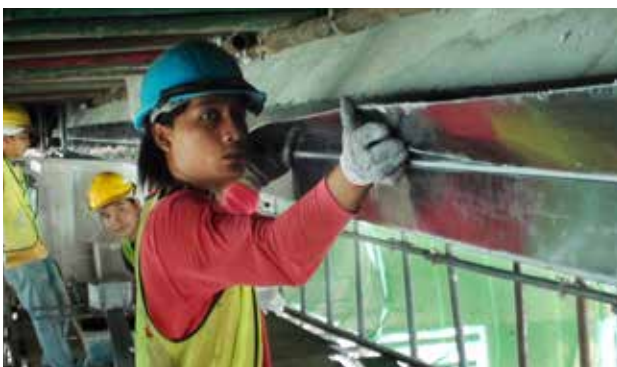
Installation CarboDur®

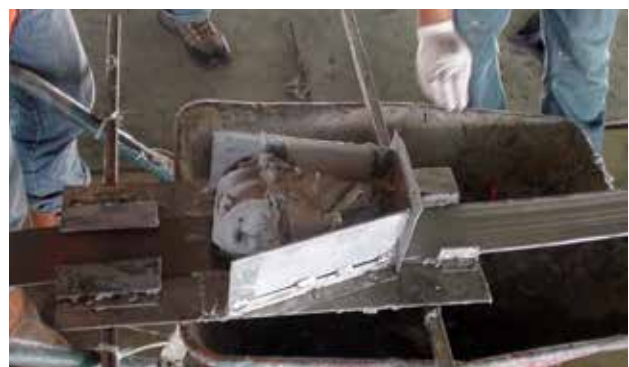
Coating of CarboDur® plates with Sikadur®

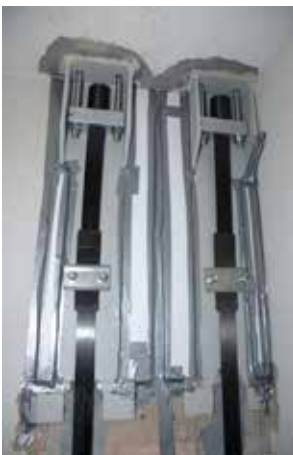
Anchorage of Sika CarboStress System

The Sika CarboStress® system was selected to achieve the necessary seismic resistance on the structure. This consisted of post-tensioned Sika CarboDur® CFRP plates anchored into the substrate. In the three stairwells of the building, a total of 12 Sika CarboStress® tendons were installed. Since these Sika CarboStress® tendons were relatively small, flexible and could be

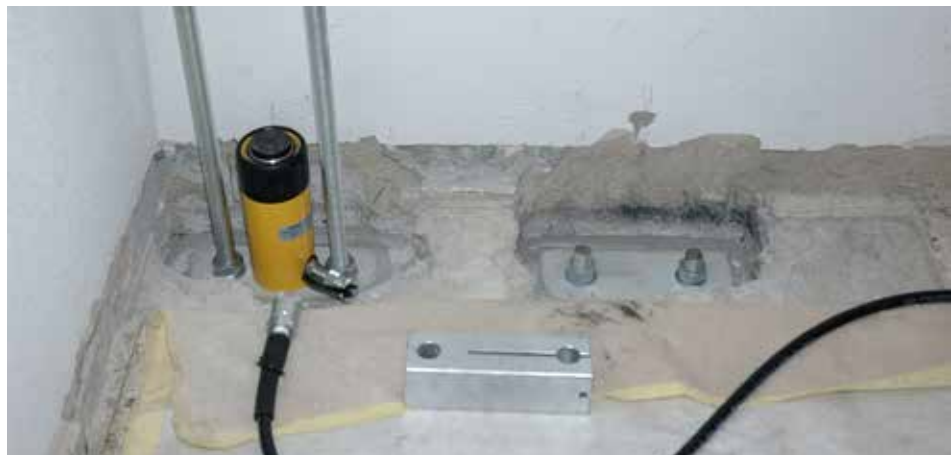
Pressure cylinder

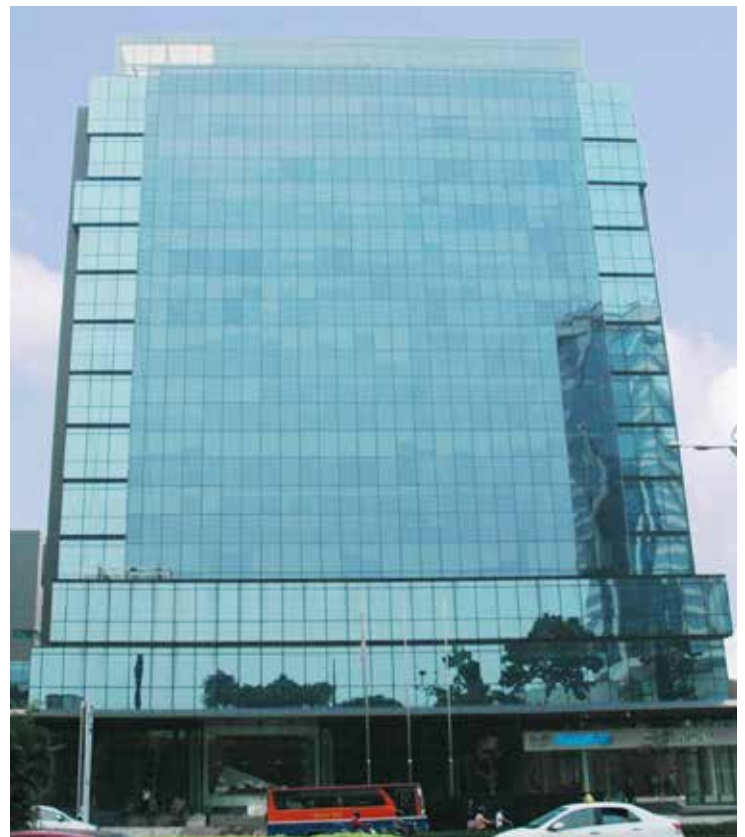
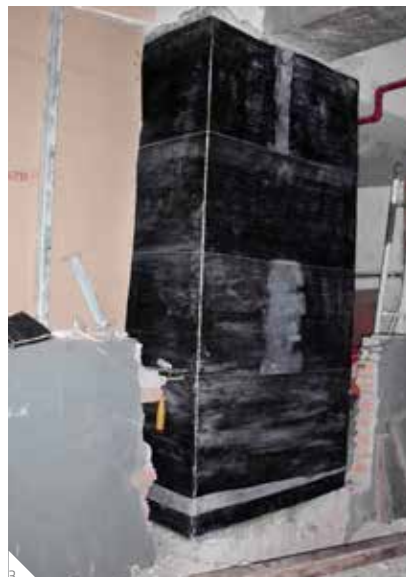
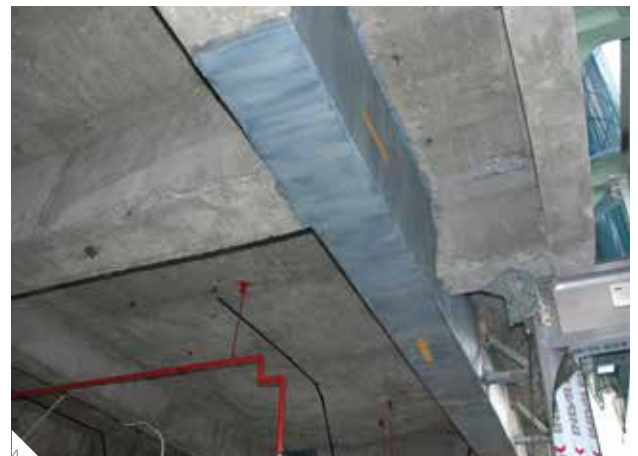
- 1 Beam strengthened without removing wall
- 2 CFRP installed around existing obstacles
- 3 Columns strengthened with SikaWrap® fabric
- 4 Reinforcement of beam with CFRP

The Engineers selected a Sika structural strengthening solution with carbon fiber-reinforced polymer (CFRP) materials, because of its effective performance despite its lightweight characteristics. Furthermore, the Sika systems allowed flexibility on site to overcome any issues and were easy to apply. The columns in the basement and ground floor were strengthened to provide increased confinement with the SikaWrap® fabric strengthening system. The cross beams were then either strengthened in flexure and against shear, or against shear only, by using a combination of Sika CarboDur® CFRP plates and SikaWrap® fabrics, with up to three layers of the fabrics being applied. During the installation works on site unforeseen conditions, including walls that could not be removed and voids in the existing concrete, were found. Another advantage of these Sika strengthening solutions was then that their design can be adjusted accordingly, so the works could still be completed successfully and with minimal break-out or removal of sound materials on site.

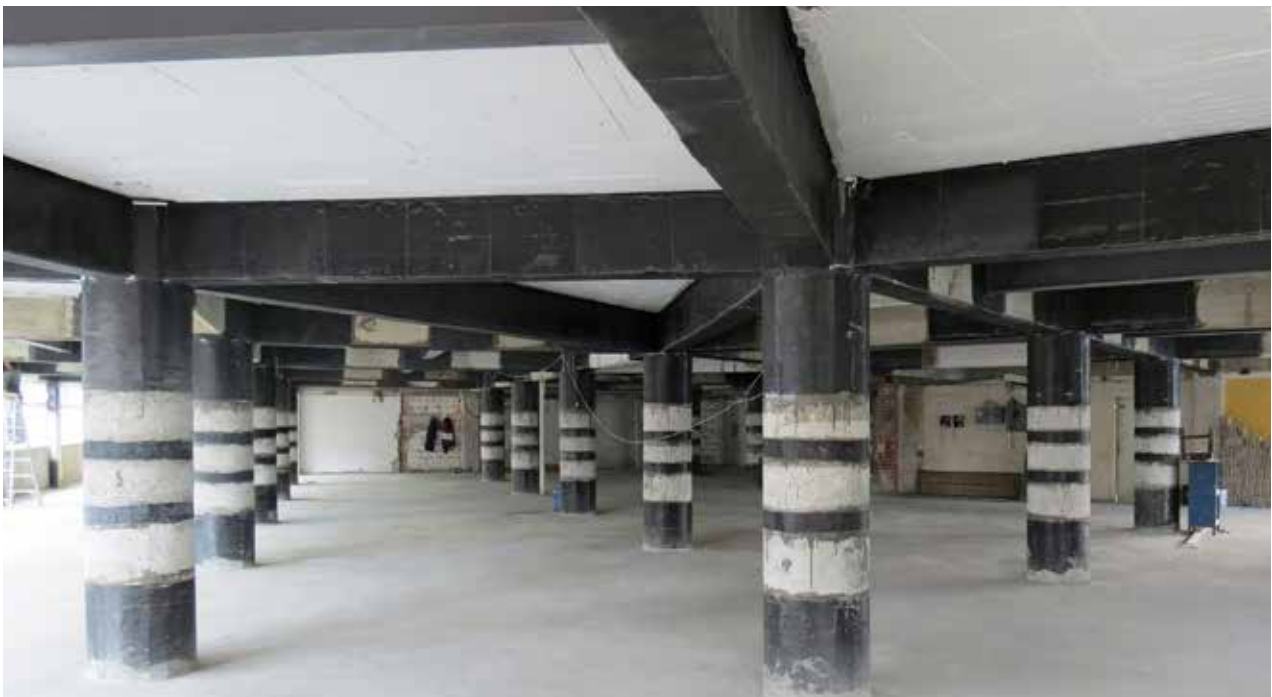
Beams and columns strengthened with SikaWrap®

A number of steps were then taken to refurbish and upgrade the whole building, including additional steel bracing and casting additional concrete, sealing existing cracks by injection and then overall structural strengthening. The beams were strengthened in flexure and shear using the SikaWrap® fabric strengthening system, the columns had continuous Sika CarboDur® CFRP plates installed along their axis over several storeys, then the columns were also wrapped with SikaWrap® fabric to increase their strength and ductility. The complete refurbishment project was easily completed on time due to the lightweight nature and rapid installation procedure for these Sika systems. The weight of the structure was only slightly increased, and no useable area was lost.

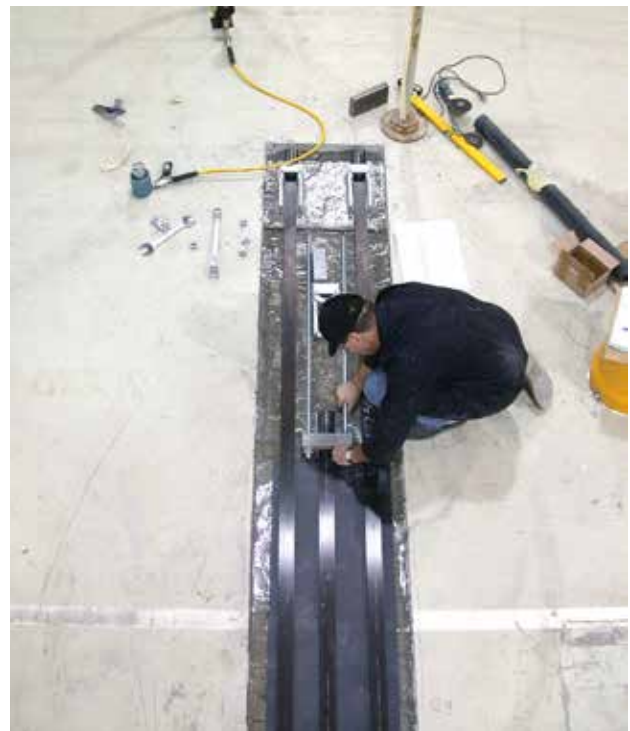
Plate and end-anchorage

System. Three tendons, consisting of CarboDur® plates and special end anchorage heads were installed to produce a united base without joints. The CFRP plates were then encapsulated into the concrete base to protect the system and to make the area ready for use.

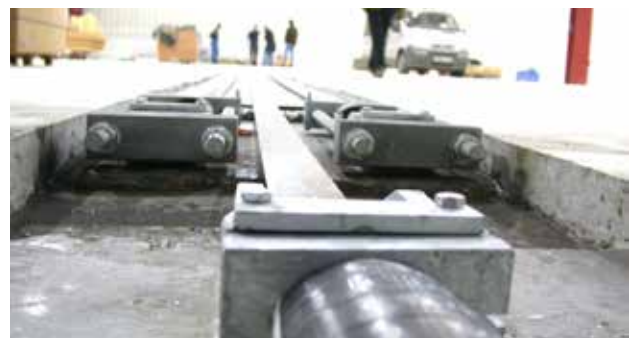
Base channel with post-tensioned CFRP plates

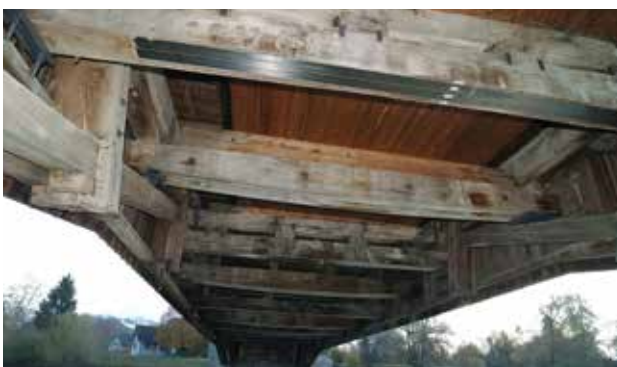
CarboDur® strengthened crossbeam

To refurbish the bridge the deck was removed and rebuilt, and Sika CarboDur® CFRP plates were bonded to the bottom of the crossbeams to reduce deflection. The installed plates were left exposed and uncoated to facilitate inspection and assessment, but to date the installation remains maintenance free.

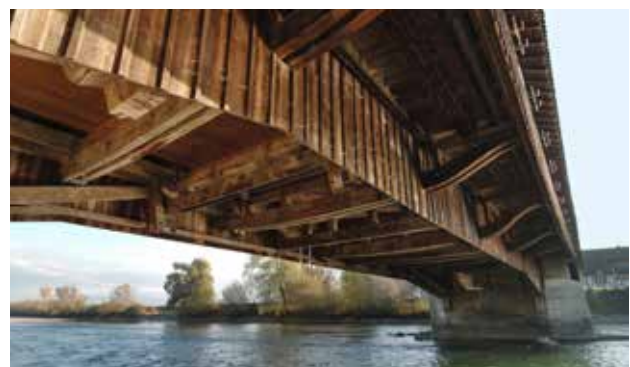
Bottom view of strengthening system

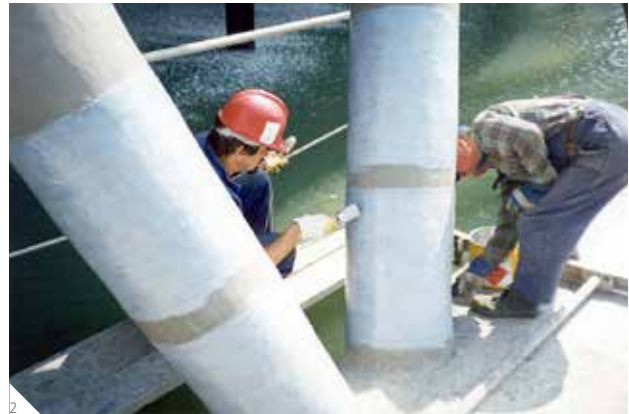
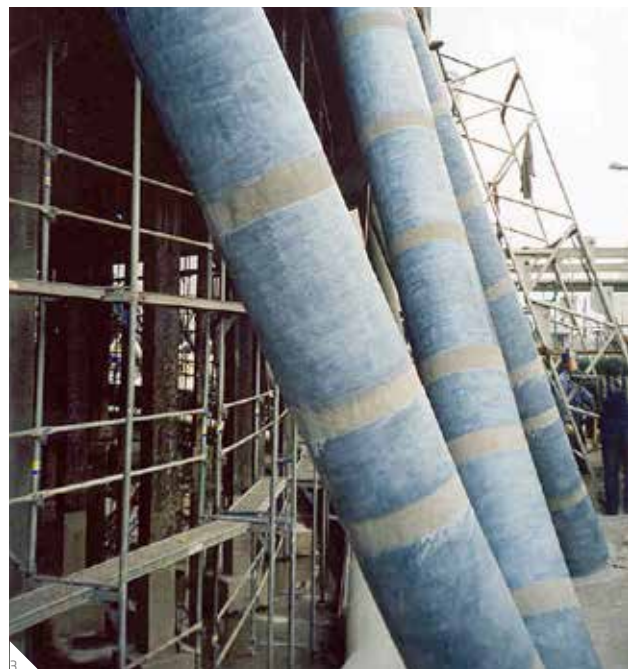
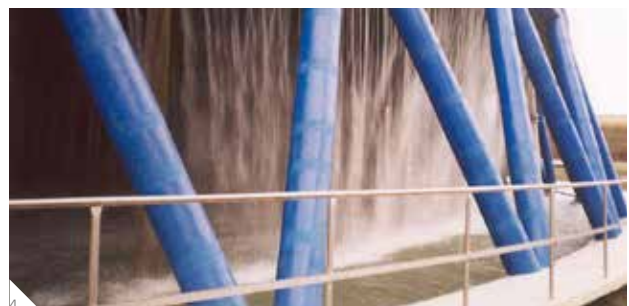
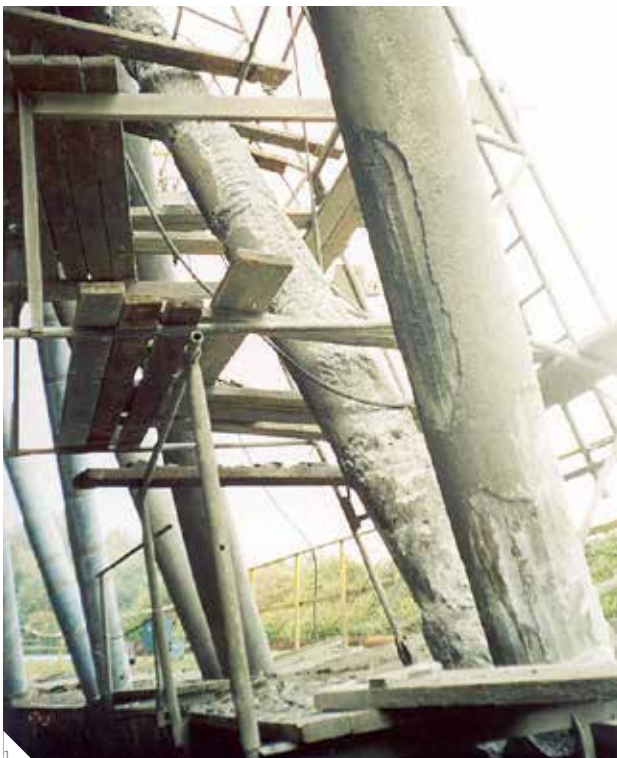
- 1 Damaged columns
- 2 Application of SikaWrap®
- 3 Installed strengthening system
- 4 Coated strengthening system

On 92 of the main supporting columns the concrete had spalled-off over corroding reinforcement in several areas, the steel was then exposed and continuing to corrode and lose significant cross section. The structure therefore now needed not only concrete repair and replacement on the damaged columns, but also a structural strengthening solution to reverse the loss of strength resulting from the corrosion and damage.

After removal of all damaged concrete and preparation of the surfaces, selected columns were repaired with sprayed concrete based on Sikacrete® admixture. The rest of all together 92 columns was then reprofiled with the Sika MonoTop® repair system and sealed with a Sikagard® impregnation. When the repairs were hardened the necessary confinement strengthening was carried out using SikaWrap® fabric in sections. Finally, all of the surfaces were overcoated with a Sikagard® protective coating for improved appearance and additional durability.

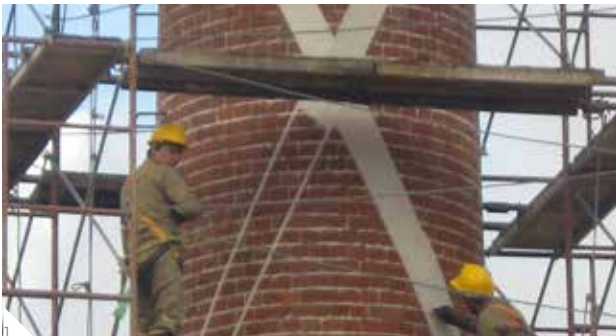
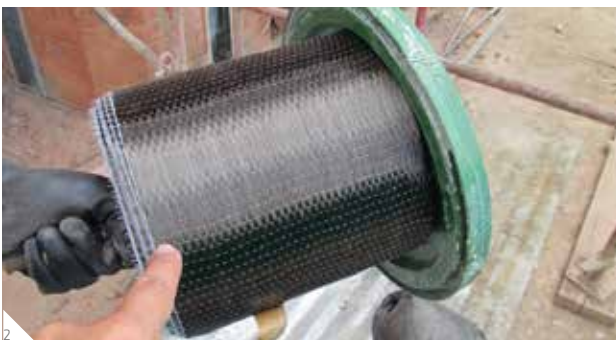
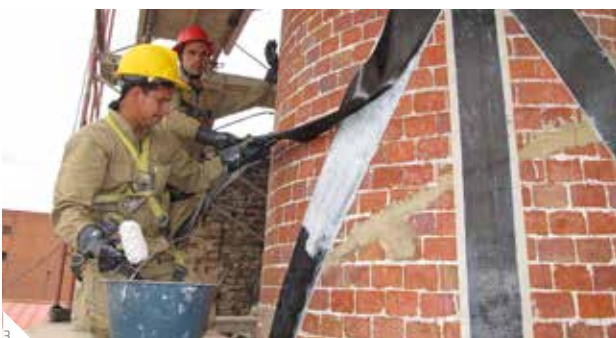
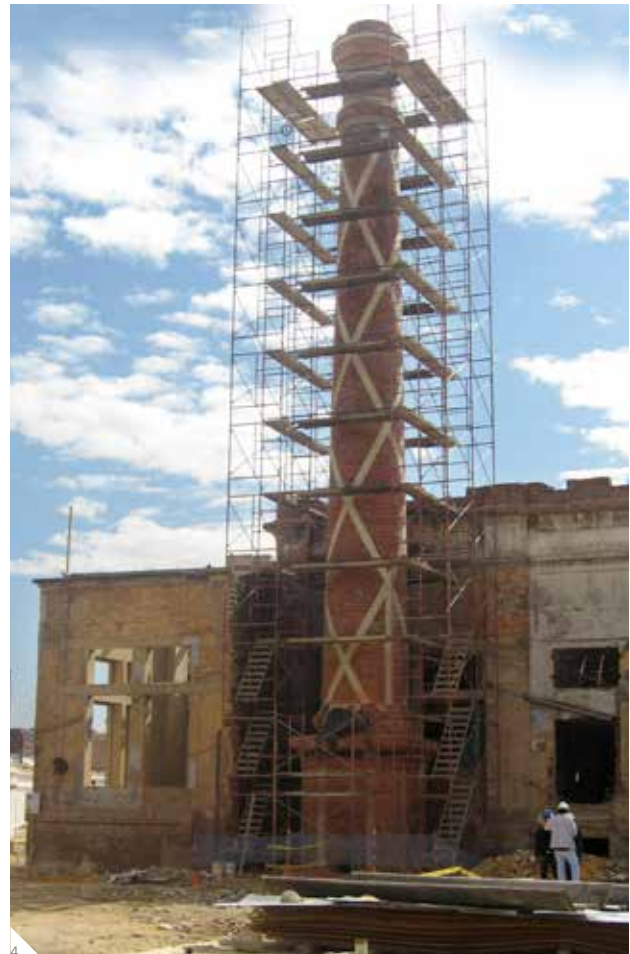
- 1 Substrate levelling
- 2 SikaWrap® roll
- 3 Installation of SikaWrap®
- 4 Coated strengthening system

A complete Sika solution was selected. After cleaning the structure thoroughly, Sikadur® epoxy mortar was applied to level the surfaces and prepare them for application of the SikaWrap® fabric strengthening system. SikaWrap® fabric strips were then cut to size and applied symmetrically, both diagonally and vertically, to improve the strength of the whole chimney structure with a uniform appearance. Finally the whole masonry chimney surfaces were overcoated with an acrylic protective coating.
