**Reinforced Concrete Silos**  
Solutions for Maintenance,  
Rehabilitation, Strengthening

# Why do Silos need Rehabilitation?

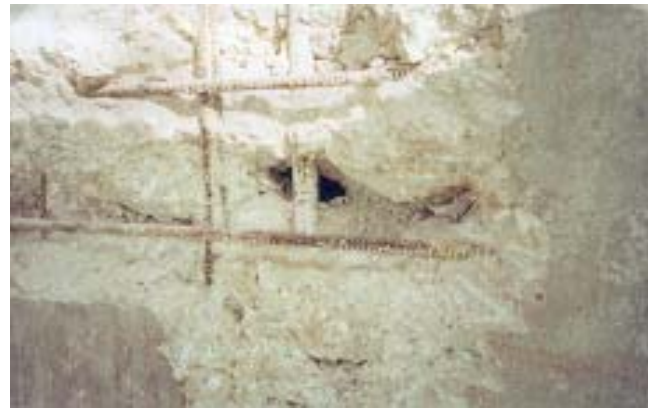
- Large vertical and horizontal cracks
- Low concrete strength
- Spalling of concrete
- Construction joints
- Corrosion of re-bars
- Reduction of concrete cover for reinforcement

- Concrete deterioration and abrasion (⇒ quality of concrete due to casting and/or curing)\*
- Overstressing in re-bars (⇒ insufficient cover of re-bars)\*
- Construction faults (⇒ inexact position of re-bars in formwork)\*
- Design assumptions (⇒ pressure, dynamic and seismic loads)
- User errors (⇒ inappropriate manipulation)
- Environmental influences (⇒ thermal variations, rain, CO<sub>2</sub>, carbonation)

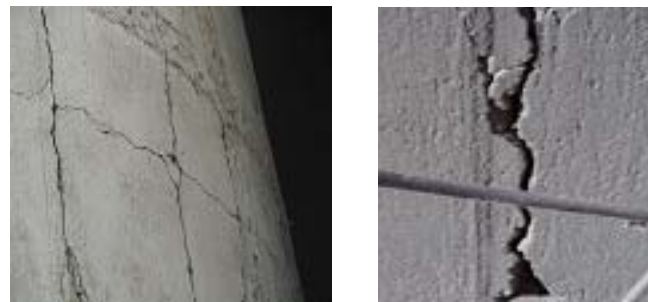
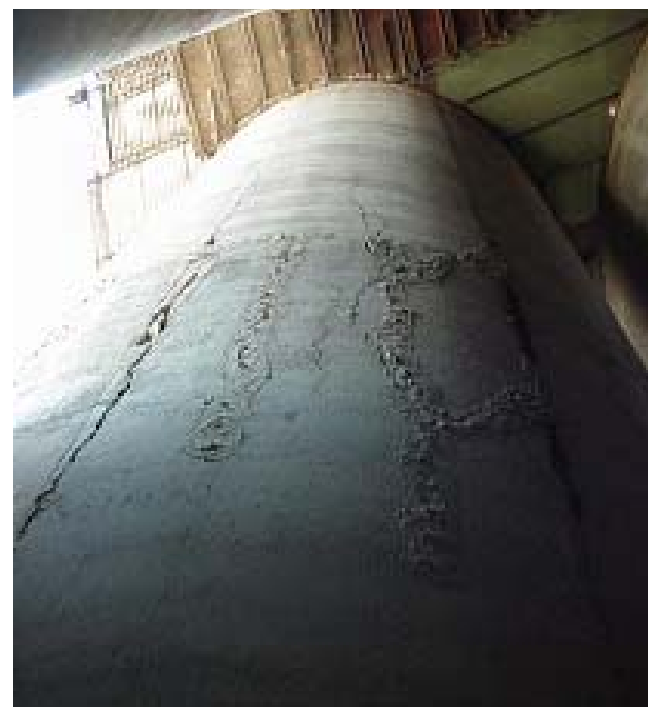
\* Silos are specially sensible to these problems because there are thin-walled structures  $t_{wall} = 20-30$  cm, erected by slip- or climbingform techniques.

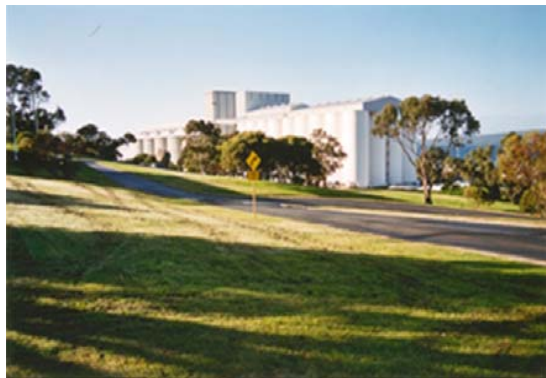
## Albany, Western Australia

Units with 16 and 20 cells  
 Diameter of a cell: 12m  
 Height of a cell: 33m

Large-vertical cracks inside of cell walls

- Injection of cracks with Sika System Solution
- Strengthening of cell walls on inside with:

- ⇒ **SikaWrap®-230 C** ca. 16'000m<sup>2</sup>
- ⇒ **Sikadur®-330** epoxy adhesive ca. 22'000kg

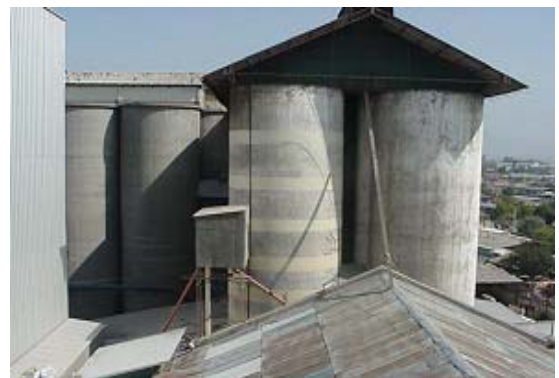
## Silo Santiago de Chile, Chile

Unit with 10 cells  
 Diameter of a cell: 6m  
 Height of a cell: 22m

- The silo presented outside cracks in several directions mainly vertical
- Inadequate spacing of reinforcement
- Concrete joints
- Low concrete strength
- Inappropriate use of space between silos (filled with wheat), this factor caused eccentric loads between silos (horizontal loads)
- Industry unable to operate under this conditions

- Prepare and clean surfaces and cracks
- Restore monolitism of the structure by epoxy injection of concrete substrate
- Externally strengthen silos with
  - ⇒ **SikaWrap®-230 C** ca. 500m<sup>2</sup>
  - ⇒ **Sikadur®-330** epoxy adhesive ca. 680kg
- Application of an UV protection
  - ⇒ **Sikagard®-550 W** coating
