STRENGTHENING SikaWrap® FX

CARBON FIBER STRINGS FOR STRUCTURAL STRENGTHENING APPLICATIONS

SikaWrap® FX - MULTIPLE APPLICATION POSSIBILITIES

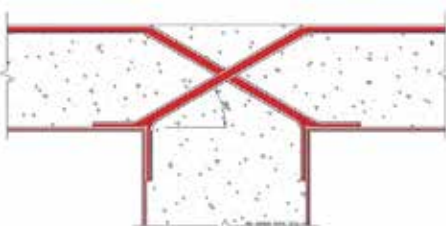
<p>6. SikaWrap® FX TO STRENGTHEN BEAM-COLUMN JOINTS</p> <p>To strengthen a beam-column joint, many layers of a CFRP fabric usually need to be applied and in a specific order and direction. As an alternative, SikaWrap® FX strings can be used in a similar way to steel dowel bars, so that the concrete elements are effectively tied together and the SikaWrap® FX system is always under tension to accommodate the required structural loading.</p>

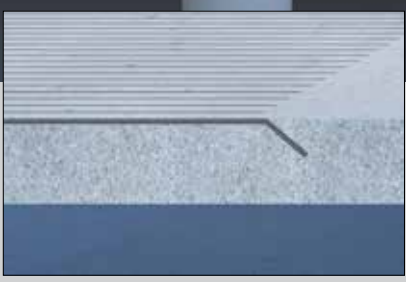
4

SikaWrap® FX for anchorage of near surface mounted (NSM) cantilevered applications

<p>4. SikaWrap® FX FOR ANCHORAGE OF NEAR SURFACE MOUNTED (NSM) CANTILEVERED APPLICATIONS</p> <p>Combinations of the anchorage and the NSM applications of SikaWrap® FX result in a useful cantilever strengthening system. This was originally developed to strengthen balcony decks, but it can also be used for many other different cantilever situations. With part of the SikaWrap® FX anchored into the main structure and the rest embedded in a slot on the balcony surface, these structures can take significantly more load.</p>

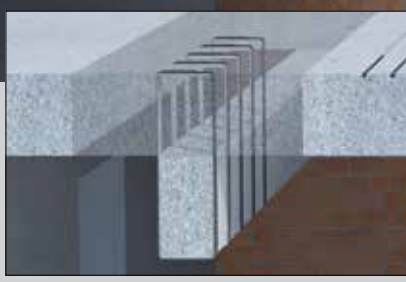
5

SikaWrap® FX for closed loop shear strengthening

<p>5. SikaWrap® FX FOR CLOSED LOOP SHEAR STRENGTHENING</p> <p>SikaWrap® FX can also be used as an alternative for the shear strengthening of beams instead of fully wrapping them with SikaWrap® carbon fiber fabrics. When using SikaWrap® FX systems this type of installation does not require the same extensive removal of damaged concrete, or the mechanical preparation of large surface areas, but only a few holes need to be drilled/cut to feed the SikaWrap® FX strings through. Where it is suitable this application is therefore cleaner, faster and easier for the same overall strengthening result.</p>

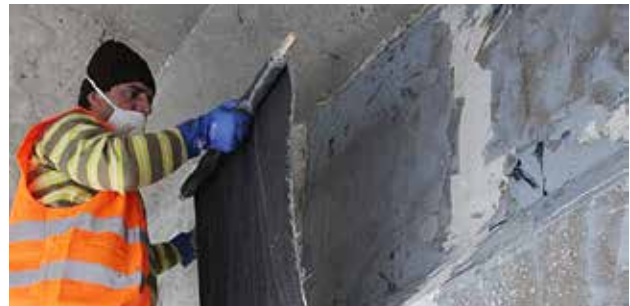
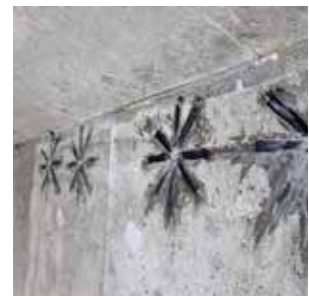
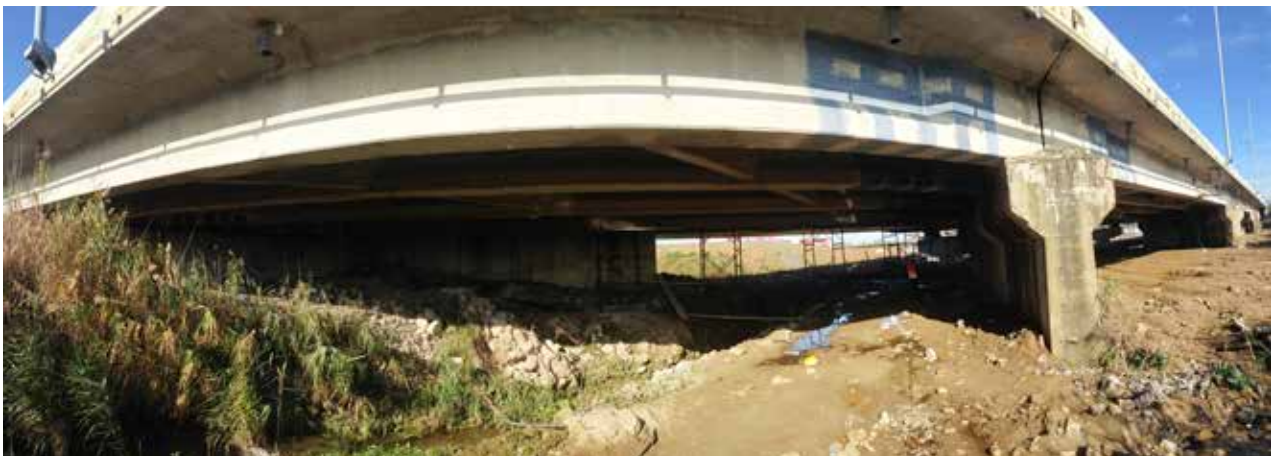
Structural retrofitting of the Krousovitis Bridge, Greece

The additional shear strength was achieved by external wrapping of the beams with SikaWrap® carbon fiber fabrics that were impregnated and bonded on site with Sikadur® epoxy adhesives. The geometry of the different cross-sections required additional anchorages for the SikaWrap® fabrics and these were provided using the SikaWrap® FX system.

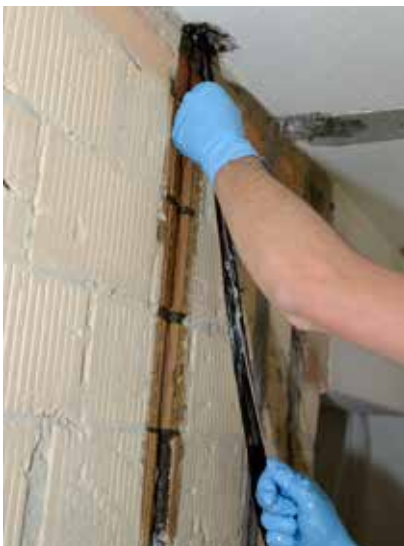
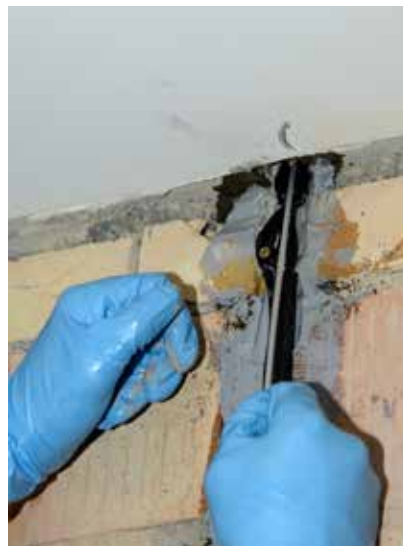
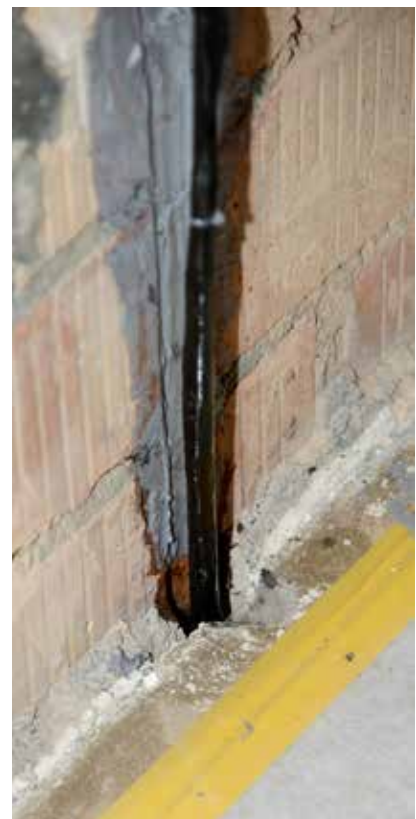
Apartment building in Rapperswil, Switzerland

Sika® CarboDur® plates were installed to strengthen the ceiling slabs and SikaWrap® FX was selected as the best option to strengthen the walls as near surface mounted reinforcement (NSM), which was used through all floor levels from the basement to the roof and in one continuous run. The SikaWrap® FX strings were impregnated with Sikadur® epoxy resin adhesive and transported on a roll with ca. 20 cm diameter, and then installed into pre-cut slots in the walls. They were covered again with Sikadur® epoxy resin adhesive and the surface was broadcast with kiln dried sand. Later test cores confirmed an excellent bond to the substrate. The Sikadur® adhesive had also penetrated approximately 2 mm into the masonry substrate. The two free ends of the SikaWrap® FX strings were fixed into the substrate as the end-anchors.

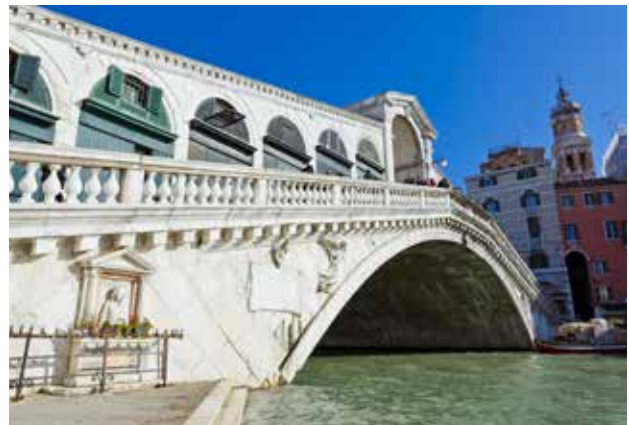
Ponte Rialto, Venice, Italy

Sika provided a complete integrated solution for all of the structural strengthening requirements using SikaWrap® fabrics to reinforce the stone cantilevers and increase the safety and support of the balustrades, thereby blocking any further rotation. This was achieved using SikaWrap® unidirectional carbon fiber fabric, impregnated with Sikadur® epoxy resin adhesive by careful manual dry application techniques. The connecting end-anchorage into the structure at each end, were formed with SikaWrap® FX carbon fiber strings, also impregnated onsite with Sikadur® epoxy resin and bonded into the stone supports with Sika AnchorFix®. The entire strengthening solution is also invisible as it is hidden under the restored deck.

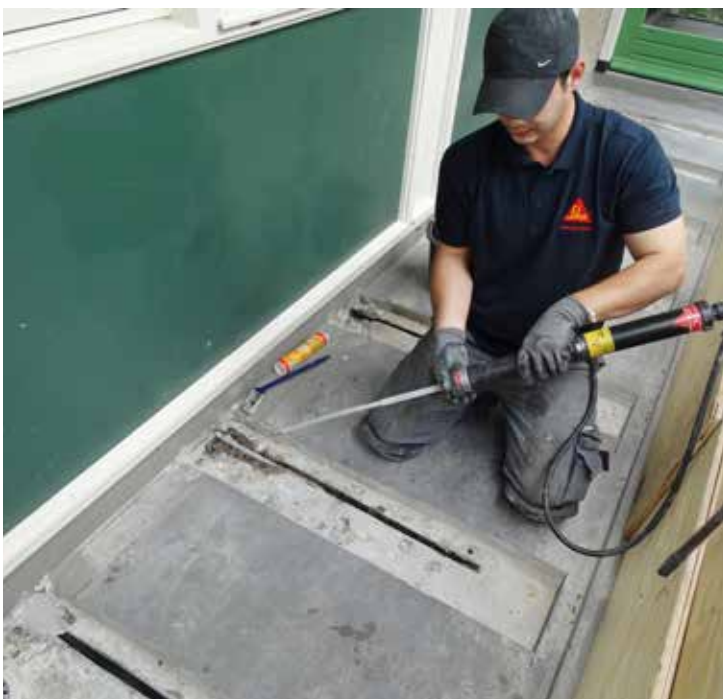
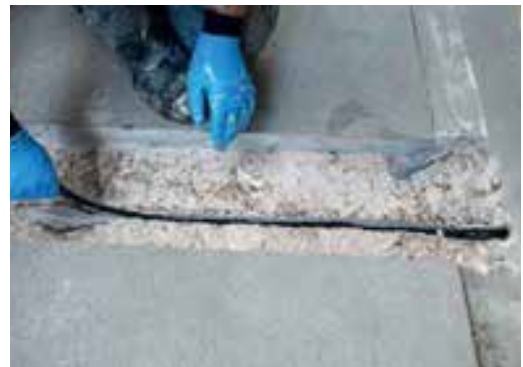
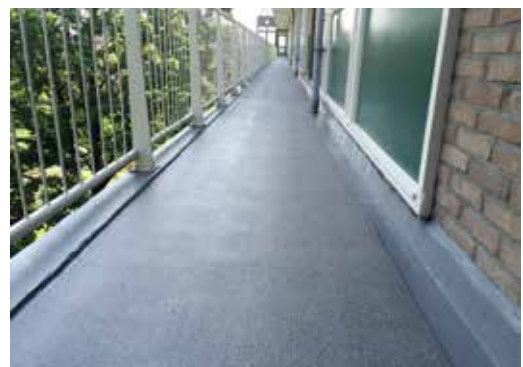
Apartment building in Leeuwarden, The Netherlands

As a result all of these decks were structurally strengthened using SikaWrap® FX carbon fiber strings as Near Surface Mounted (NSM) reinforcement. This Sika system was applied by cutting slots approximately 30 mm deep in the concrete surface, which could be done relatively easily and without any heavy equipment. The ends of these SikaWrap® FX strings were then anchored using Sika AnchorFix® epoxy adhesive, into additional holes drilled into the main structure. The load bearing capacity was therefore increased ensuring future stability and safety.

Once the SikaWrap® FX strings had been installed, the slots were re-filled using a fast-hardening Sika cementitious flooring system. The balcony decks were then sealed and made waterproof to prevent future water and chloride ingress, using a fast-drying Sikafloor® Pronto (acrylate resin based) deck coating system that also provides a range of decorative finishes.

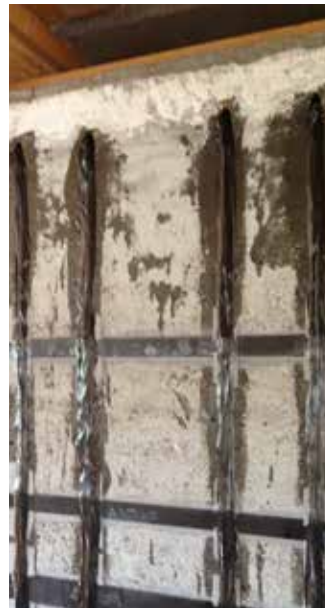
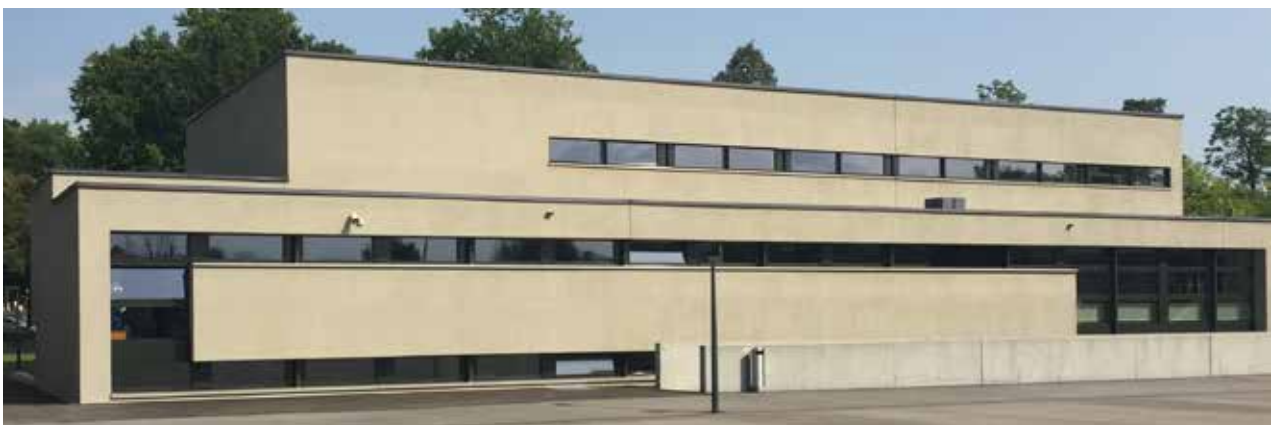
Extension of a Sports Hall, Biberstein, Switzerland

Using steel links or strengthening by completely wrapping the beam with a composite fabric strengthening system was not possible because the concrete floor slab is supported directly on the top of the beam. The engineers therefore selected to use the SikaWrap® FX system as the best alternative option, which consisted of the carbon fiber strings bonded directly onto the prepared sides and bottom of the beam, and through the core holes drilled at the top of the beam. Once the strings had hardened the holes were filled and sealed with Sika AnchorFix® epoxy resin. In this way the engineers were able to fulfill the same strengthening requirements as complete CFRP fabric wrapping, but with a system that was also practical to install.

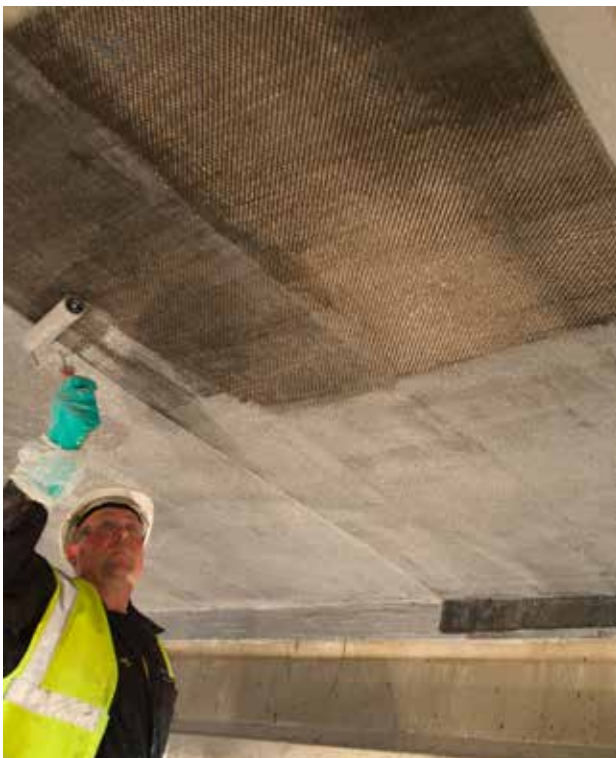
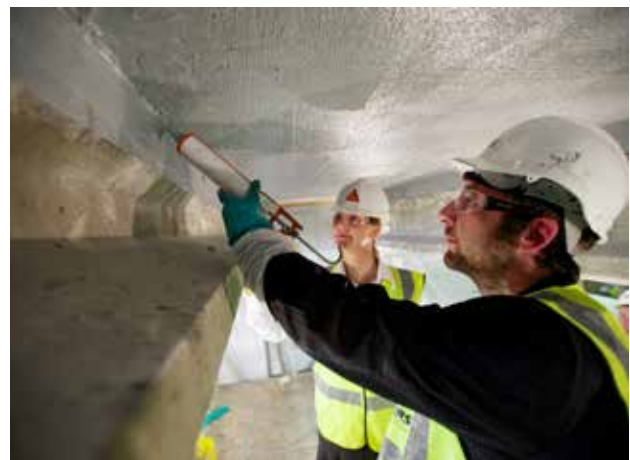
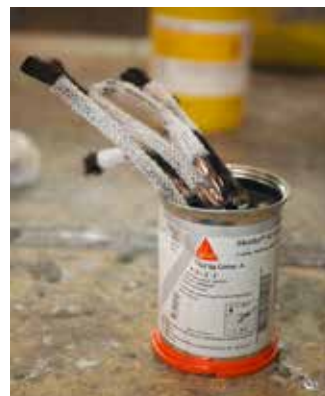
Merrion Centre MSCP, Leeds, UK

During the carbon fiber design phase, the calculations showed a potential peeling issue with the fabric applied on the soffit of the slabs where they met the supporting beams. However this issue was solved by introducing SikaWrap® FX carbon fiber strings as anchors installed into holes predrilled into the beams at an angle of 30° above horizontal, with the SikaWrap® fabric reinforcement then applied and bonded over them.
